LX Flarm units

Firmware update procedures

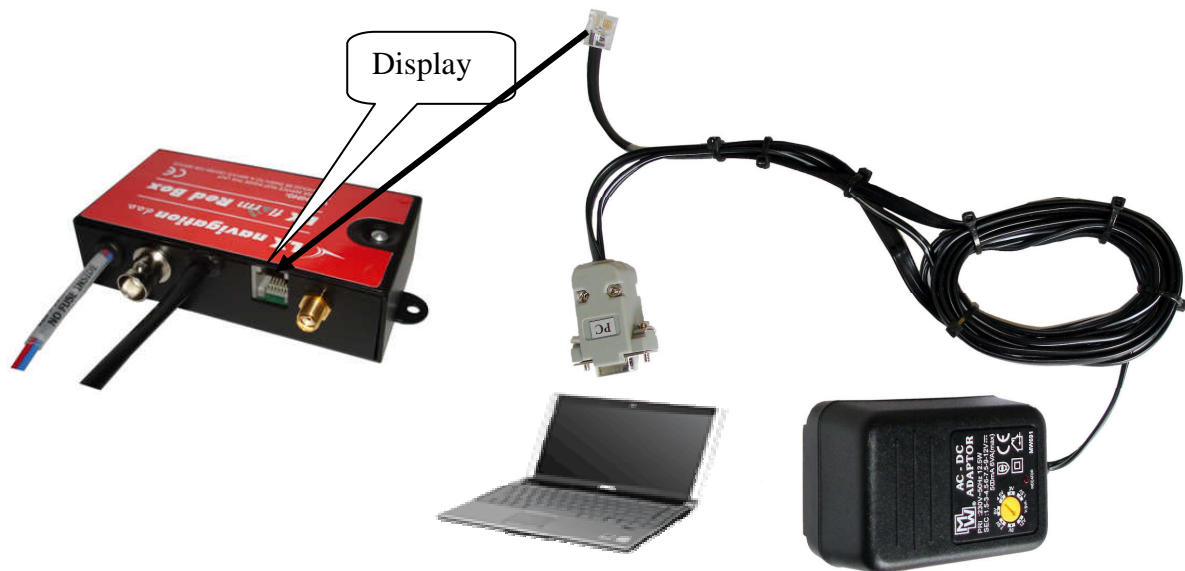
Schematics of Red Box, PC and Colibri adapter connection

Important!
Plug 6P telephone type connector into **Display** marked connector of Red Box.

Important!
Using of above mentioned cable set will also power Red Box from AC network. This configuration is therefore extremely comfortable for indoor operation.

This cable set may be also used for update of Red Box **units built into** the glider. In that case remains AC plug **unplugged**.

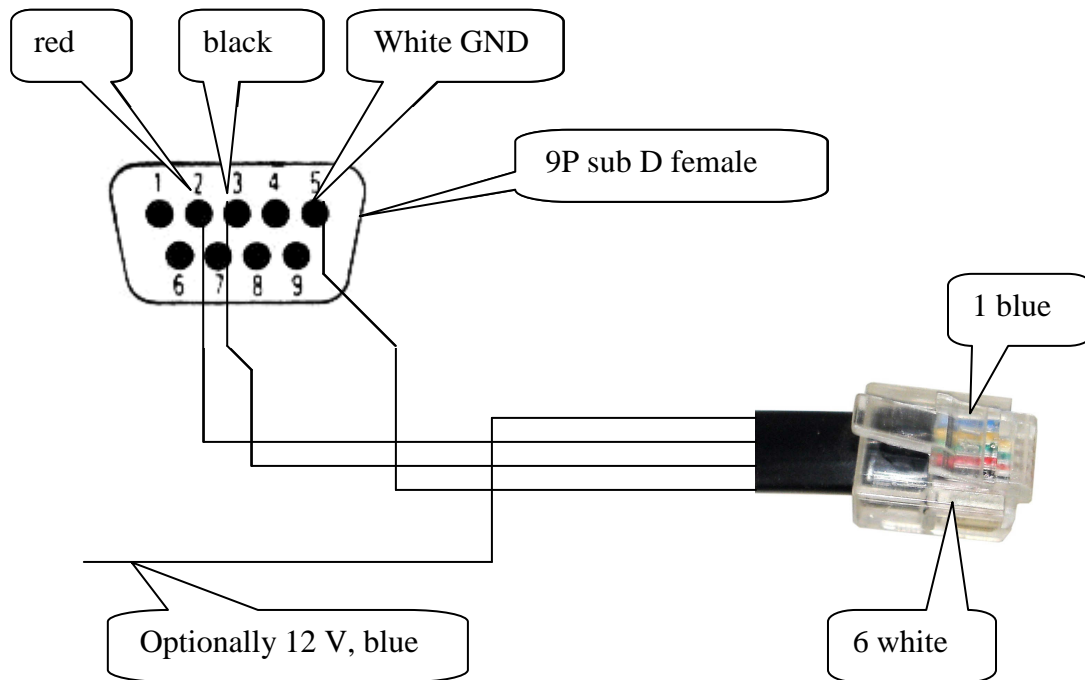
Detailed schematics of LX Flarm update cable

Note!
Optional 12 V and GND may be extended, wires 1 (blue) and 6 for indoor operation.

This cable ensures data exchange **Red Box - PC** during the update procedure. This cable doesn't include power lines and therefore don't power Red Box. This configuration is suitable for field operation where Red Box receives power from the glider battery.

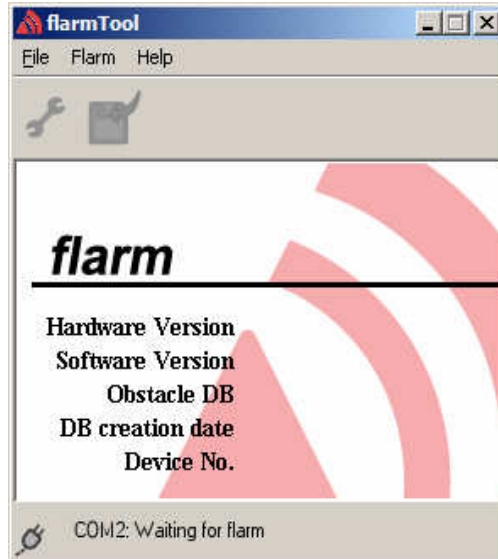
Flarm tool ready on com 2

- **Run** Flarm tool (a free com port will be selected automatically)

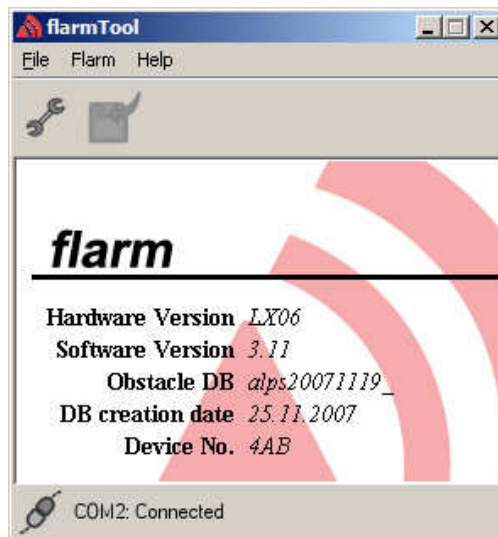
Connect status established
(HW,FW, data base and device number visible)

- Connect cable to **PC** (9P)
- **Remove** Flarm external display (not necessary by Mini Box)
- Plug 6P telephone connector into **Ext. Disp.** Plug of the Red Box, USB type by Colibri
- Power Flarm **ON** (not necessary after using of Colibri adapter),
- Wait until connection will be **established** (it will take up to 30 seconds)

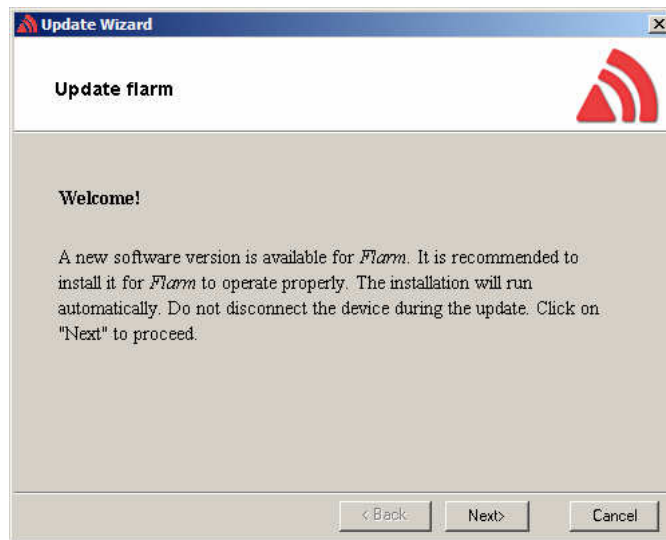
- The update procedure will start **automatically**, after successful connection
- Follow wizard on PC and wait until **Finish**

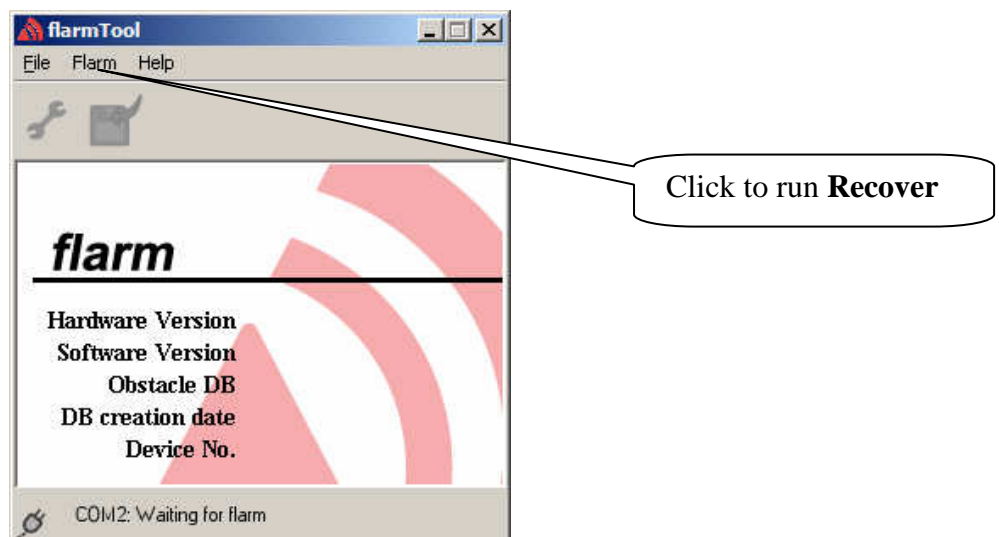
This procedure should be used after the first procedure **has failed**. To do this it is necessary to start so called **RECOVER** item. It is available after click on FLARM.

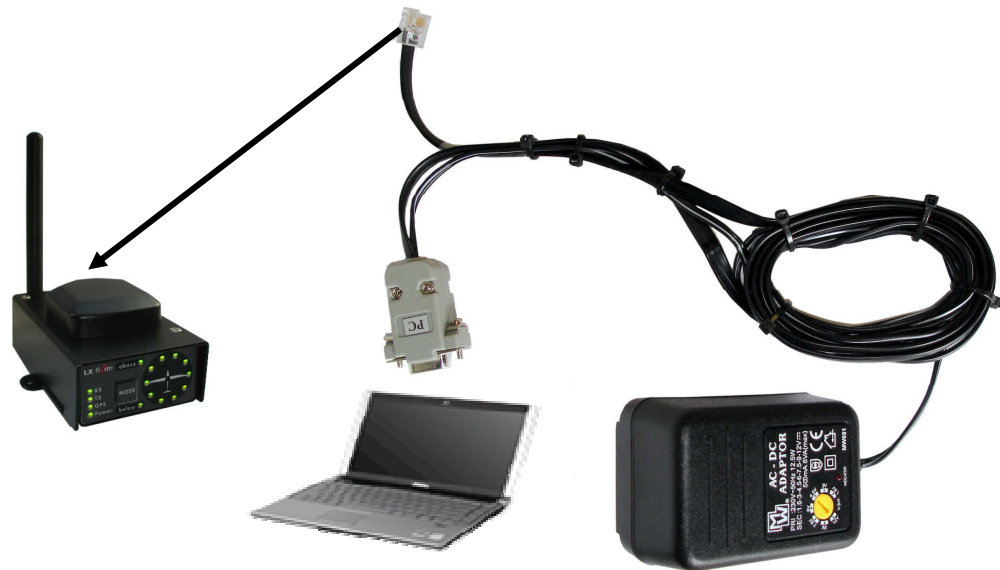
The update can be carried out exclusively after connection to PC. Recommended cable set is Colibri power and data adapter (see 3.2.1.1). Extended LX Flarm update cable can be also used.

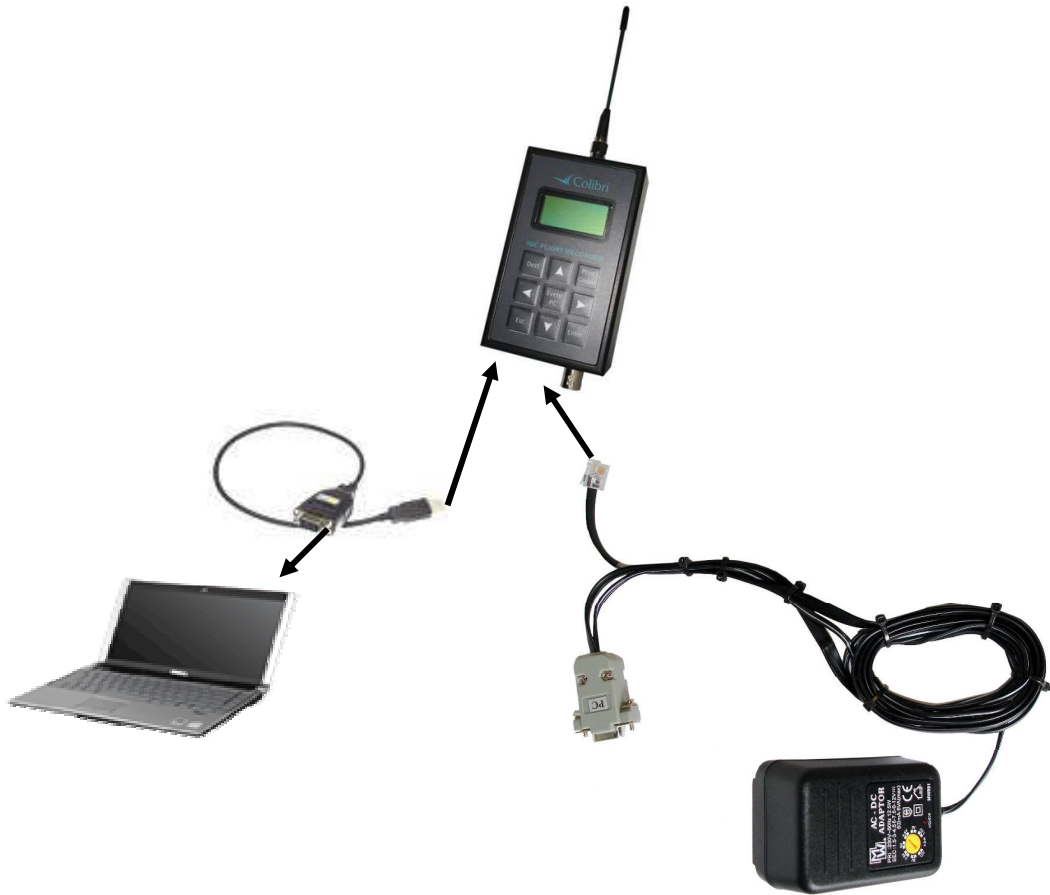
Colibri Flarm, Flarm update configuration

All necessary cables are delivery included (Colibri adapter, Colibri Flarm update cable). Update is possible **exclusively** after data transfer Colibri Flarm - PC. **No way to update** via Colibri SD card. Colibri Flarm update cable (USB to 9P Sub D) should be used for data transfer and Colibri adapter will **only power** the unit.

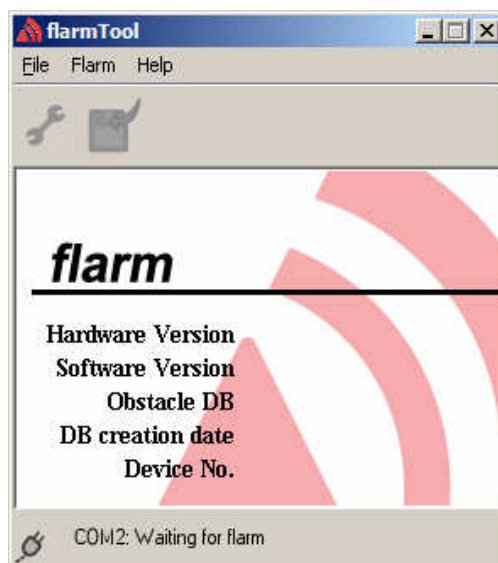
Flarm tool ready on com 2

- **Run** Flarm tool (a free com port will be selected automatically)

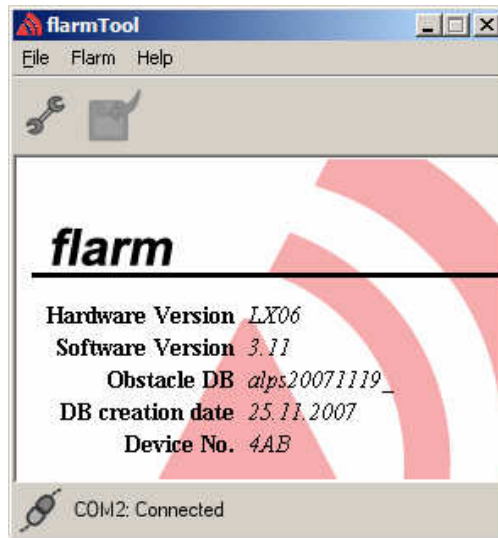
Connect status established
(HW,FW, data base and device number visible)

- Power Colibri ON
- Wait until connection will be **established** (it will take up to 30 seconds)

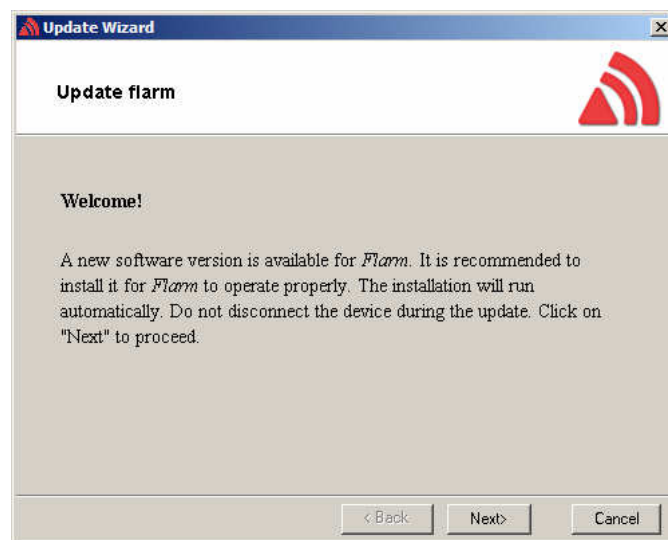
- The update procedure will start **automatically**, after successful connection
- Follow wizard on PC and wait until **Finish**

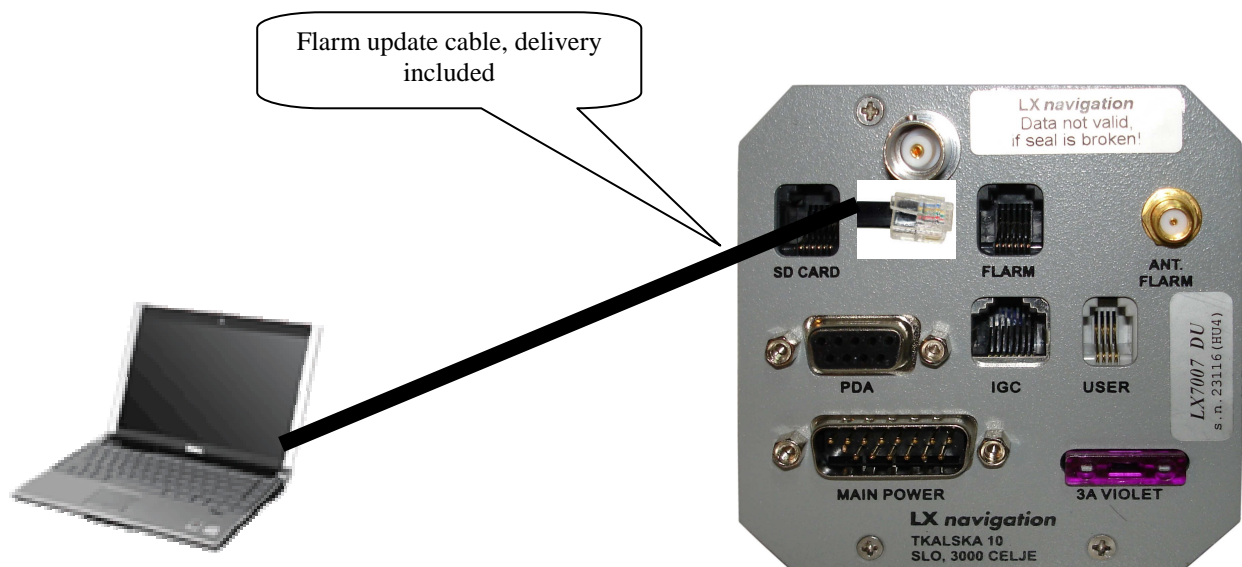
It is necessary to **disconnect** Flarm external display and to plug 6P telephone type connector of the Flarm update cable into FLARM marked socket of LX 7007.

Flarm is a separate board integrated into LX 7007 housing. The only way to provide firmware update is to connect Flarm board with PC. A suitable **cable** designated as Flarm Update cable (Ord. nr. LX7-F-UD-cable) is delivered with **every** unit.

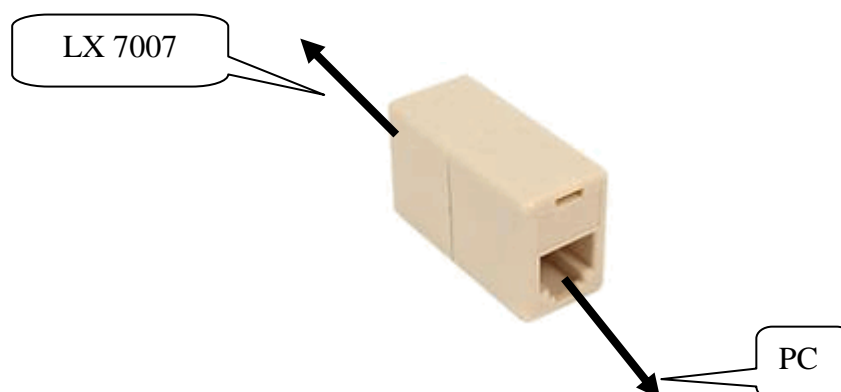
If FLARM marked connector isn't easy to reach, use a RJ11 female to female interface which is available in nearly every telephone shop. This will make possible to connect the update cable close to the Flarm External display and this position is normally easy to reach.

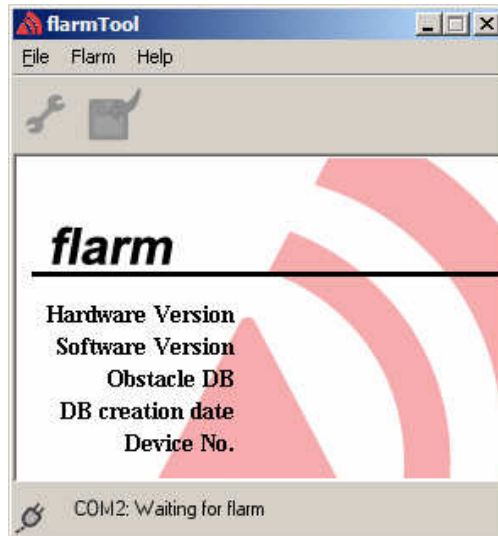
Flarm tool ready on com 2

- Switch **LX 7007 ON** and wait until booting will finish
- **Run** Flarm tool (a free com port will be selected automatically)

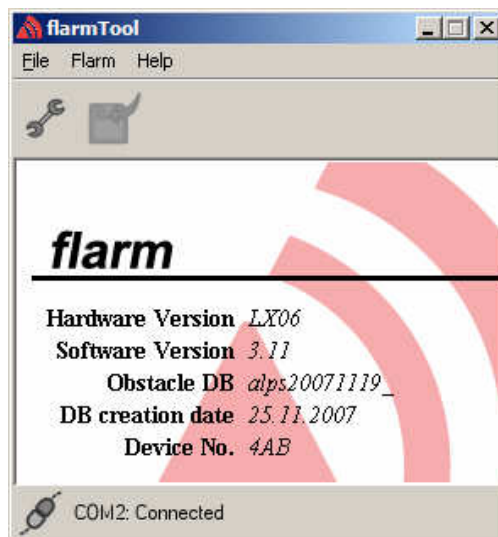
Connect status established
(HW,FW, data base and device number visible)

- **Remove** Flarm external display
- **Connect** Flarm update cable to **PC** (9P) and **LX 7007** (6P)
- **Wait** until connection will be **established** (it will take up to 30 seconds)

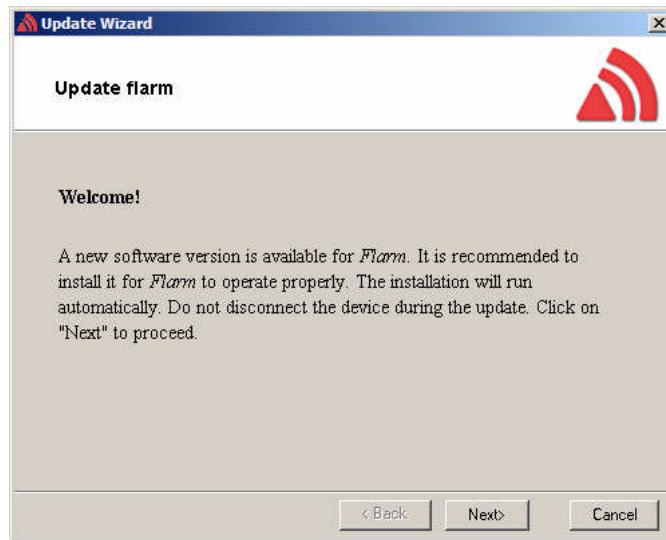
- The update procedure will start **automatically** immediately after connection
- Follow wizard on PC and wait until **Finish**

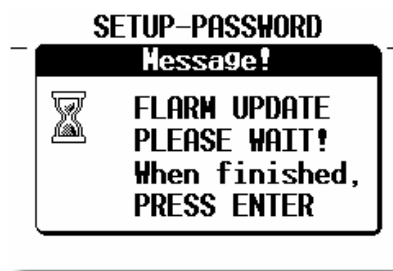
- Input **password 41000** on LX 7007 System Setup\Pasword
- A message window will open

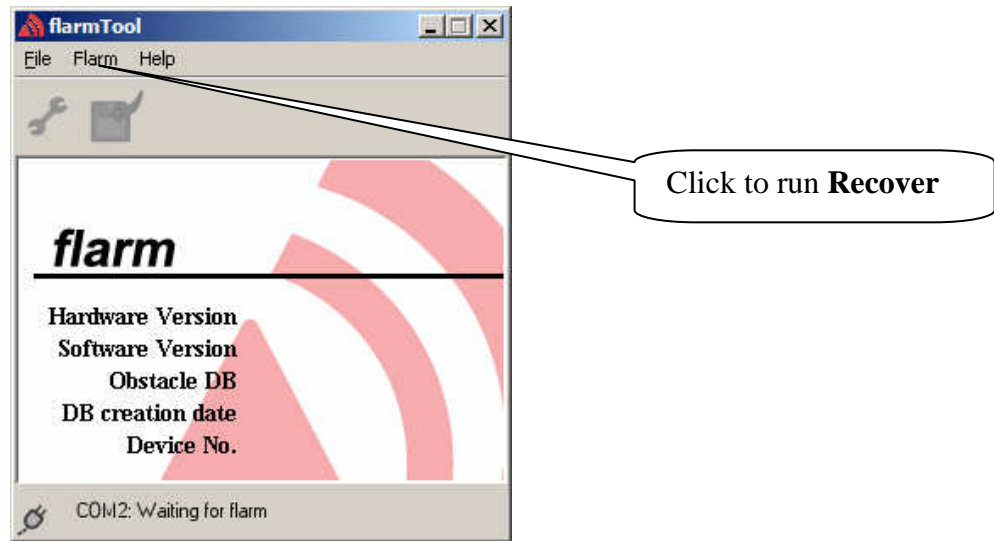
- **Run** Flarm tool
- Click on **Flarm** and after on **Recover**
